## Assessment of Drainage Structures and Their Impact on Traffic Flow Along an Urban Arterial Road Corridor

### Abstract

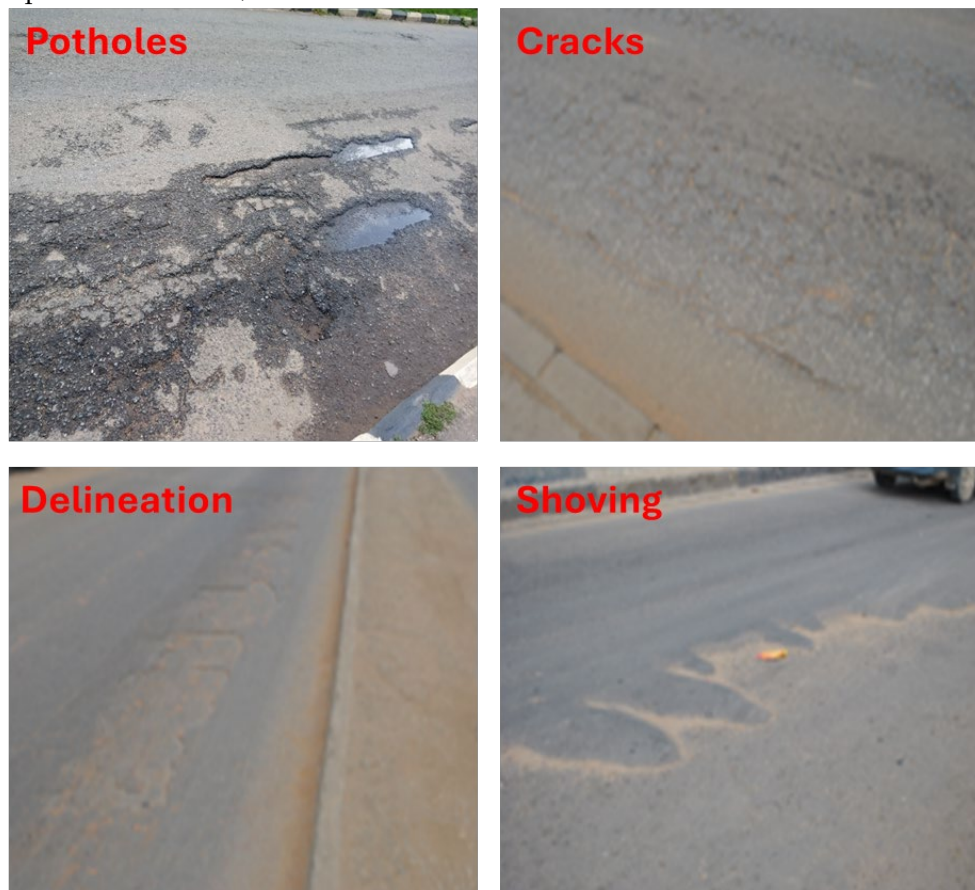
Plate 1: Pavement distress observed on the road

The road condition survey showed that maintenance is irregular. Widespread distress includes potholes, surface cracks, delineation, and shoving, as shown in Plate 1. Most of the bus stops were observed in deplorable condition, as shown in Plate 2.

The road condition survey revealed extensive pavement distress, including potholes, cracking, shoving, and surface deformation. These defects indicate that the pavement is experiencing structural and functional deterioration.

From a pavement engineering perspective, the observed distresses are consistent with moisture-induced pavement failures. Water entering the pavement layers through cracks and poorly functioning drainage facilities reduces subgrade strength and accelerates fatigue damage. The concentration of pavement distress near drainage structures rated poor further supports this relationship.

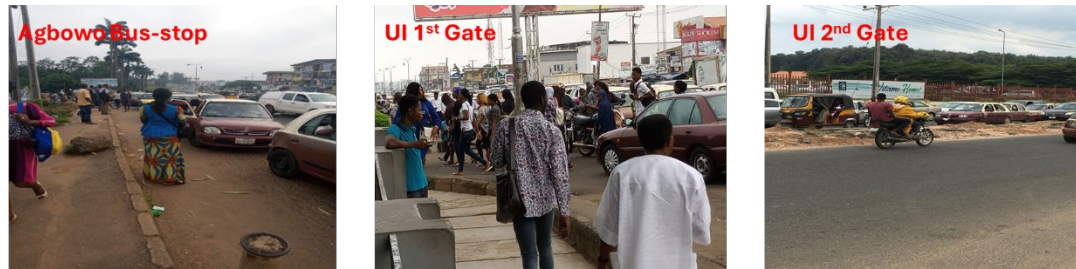
Plate 2: Bus-stop condition survey

The poor condition of most bus stops also reflects insufficient infrastructure maintenance. Well-maintained bus stops are expected to provide passenger comfort, improve traffic organization, and enhance road safety. Their deterioration may contribute to unsafe passenger loading and unloading activities, thereby affecting traffic operations along the corridor.

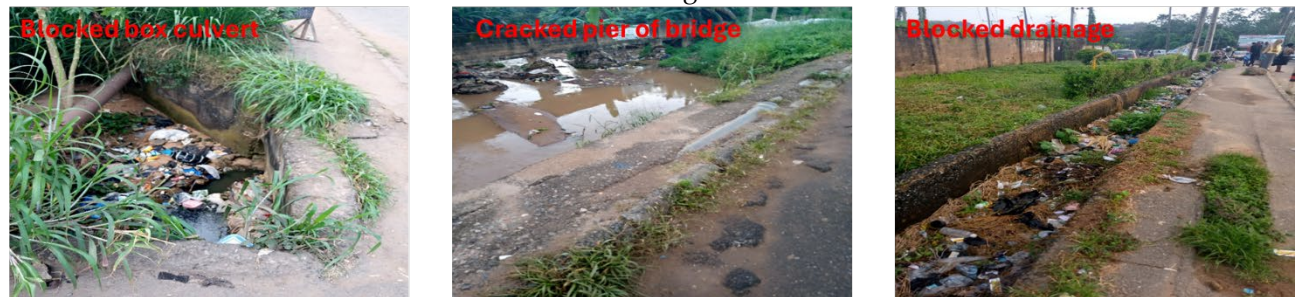
Plate 3: Drainage condition survey

Six drainage structures along the route are in good condition; one is fair, and five are in poor condition. Plate 3 depicts the blocked end of the box culvert at CH. 0+200, and Plate 3, the cracked pier of the bridge at CH. 5+300. Others include blocked drainage structures at CH. 10+500. These poor conditions of the drainage structures could have contributed to the observed flooding on the route.

Furthermore, the blocked box culvert at CH 0+200, which is the first structure encountered at the UI First Gate end of the corridor, contributes directly to flooding at the intersection during moderate to heavy rainfall. This flooding temporarily closes one or more lanes of the extended carriageway, causing a sudden and significant reduction in capacity that triggers queue spillback extending hundreds of meters in both directions.

The blocked box culvert at CH 0+200 and the damaged bridge components observed during the survey indicate that sediment accumulation, debris obstruction, structural deterioration, and insufficient maintenance are affecting hydraulic efficiency. According to drainage management guidelines, drainage structures should operate with minimal obstruction to ensure the free flow of runoff. Therefore, the observed conditions indicate reduced drainage capacity in critical sections of the corridor.

- The principal drainage defects observed include a severely blocked box culvert at CH 0+200, cracked bridge piers at CH 0+780 and CH 2+450, and blocked surface drainage channels at multiple locations.

| Condition Rating | Number Structures | of | Percentage (%) | Recommended Action |
|---|---|---|---|---|
| Poor | 5 | | 41.7 | Rehabilitation within 6 months |
